## BRM Feed Lot Management Plan

F8285

### Project Details

Project Name	BRM Feedlot
Client	Ben & Rennae McInnes
Report Authors	Samantha Grainger, Mark Carter
PMC Project Reference	F8285

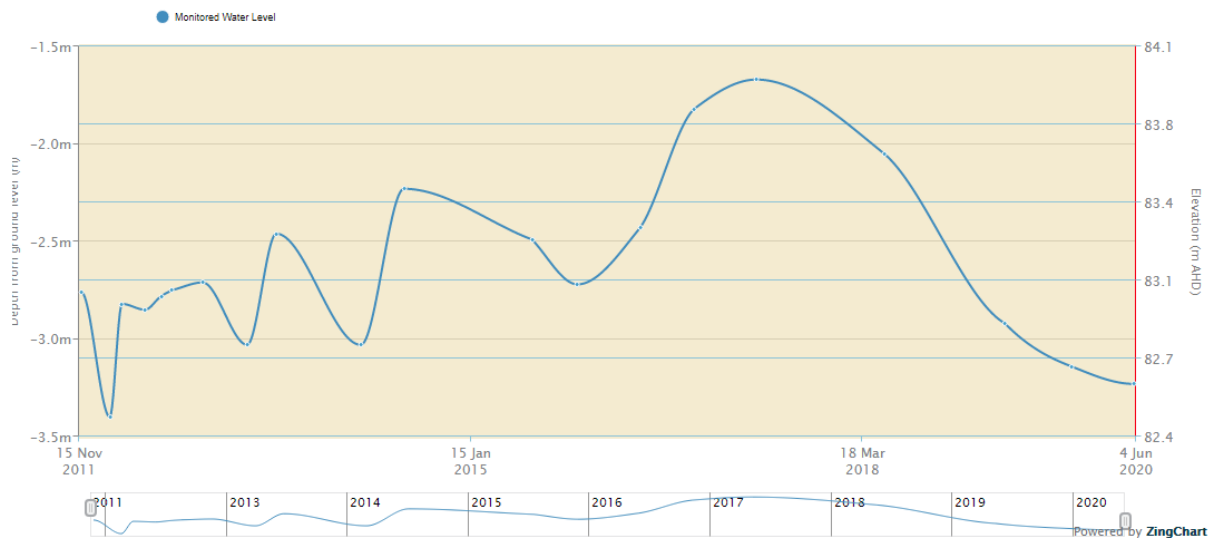
**Figure 8: Bore Data -128278 (2011-2020)**

Bore data indicates water table is currently at >3m.

Bore data in the area of the Gibbons Road and Patho paddocks indicate that groundwater levels are in the region of >3m from the surface. (Bore ID:128278 Visualising Victoria's Groundwater website). There are a limited number of actively monitored bores in the immediate area.

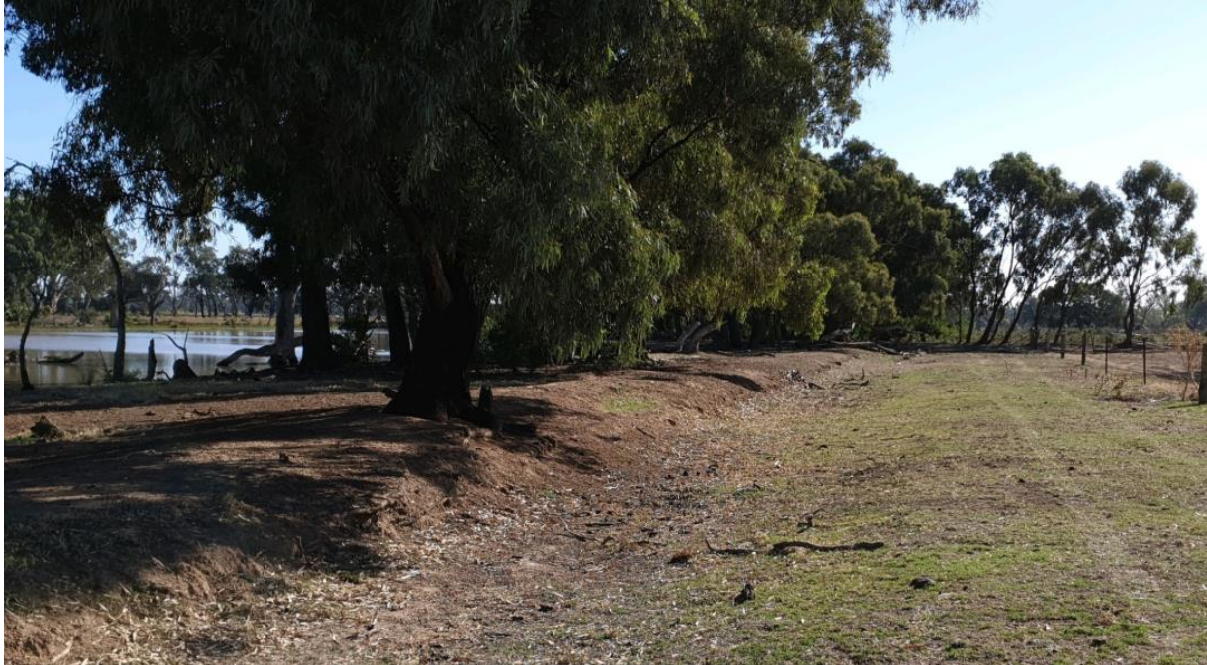
**Figure 10: Photo showing bank and fencing**

According to NCCMA potential flood levels in a 1% AEP are restricted to the creek and lagoon alignments and no overland flow is expected. The presence of constructed banks around the perimeter of the property would prevent flooding. See supplied Site Plans.

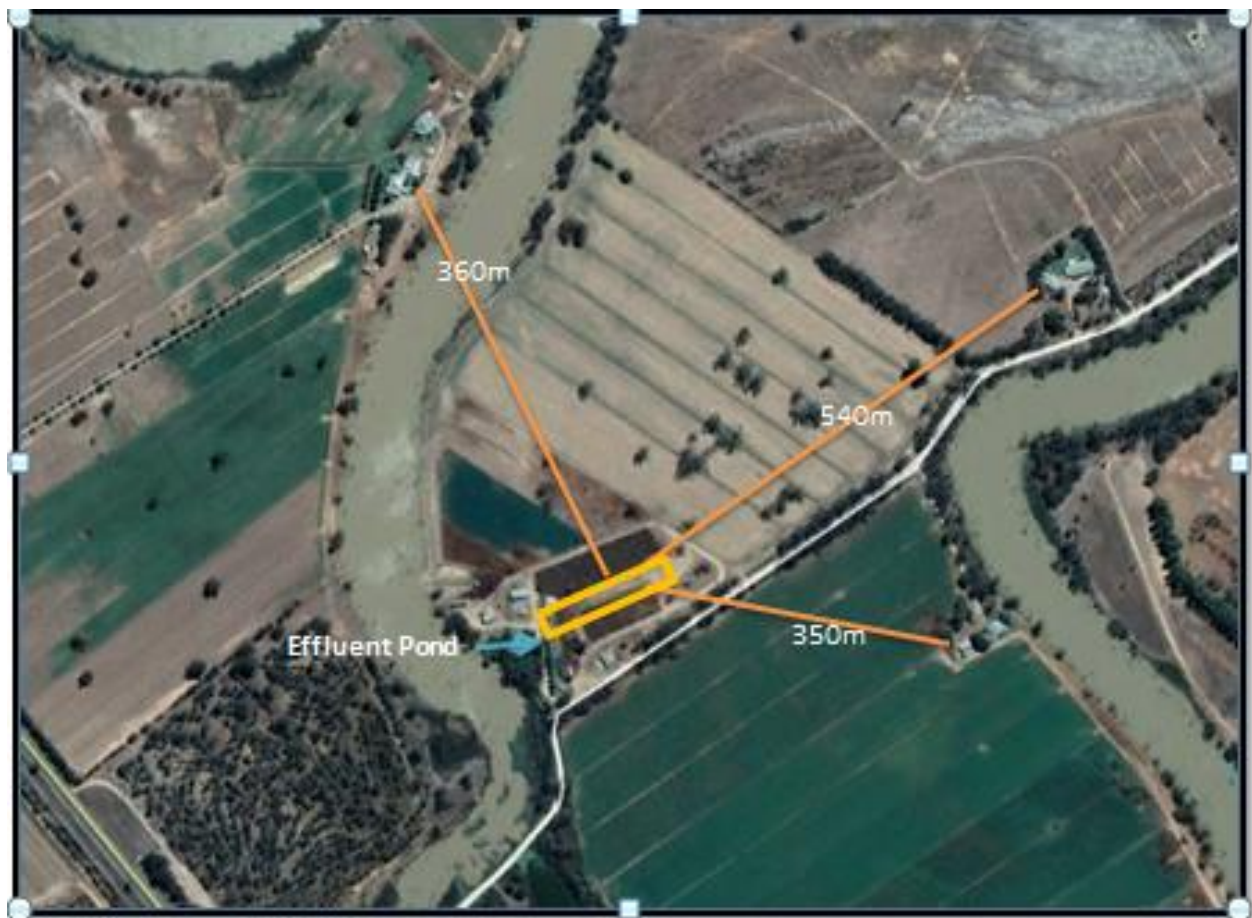
Figure 12: Distance to sensitive receptor from effluent pond

These are private dwellings and can all potentially be impacted by the Feedlot area through odour and dust. Setback distances are the most effective way to control the negative impacts of such developments. The guideline recommends 300m as suitable from the effluent pond, according to the Guidelines for Victorian Dairy Feedpads and Free stalls. The effluent pond only contains stormwater runoff as no pen wash down is carried out, and operates basically as an evaporation pond.

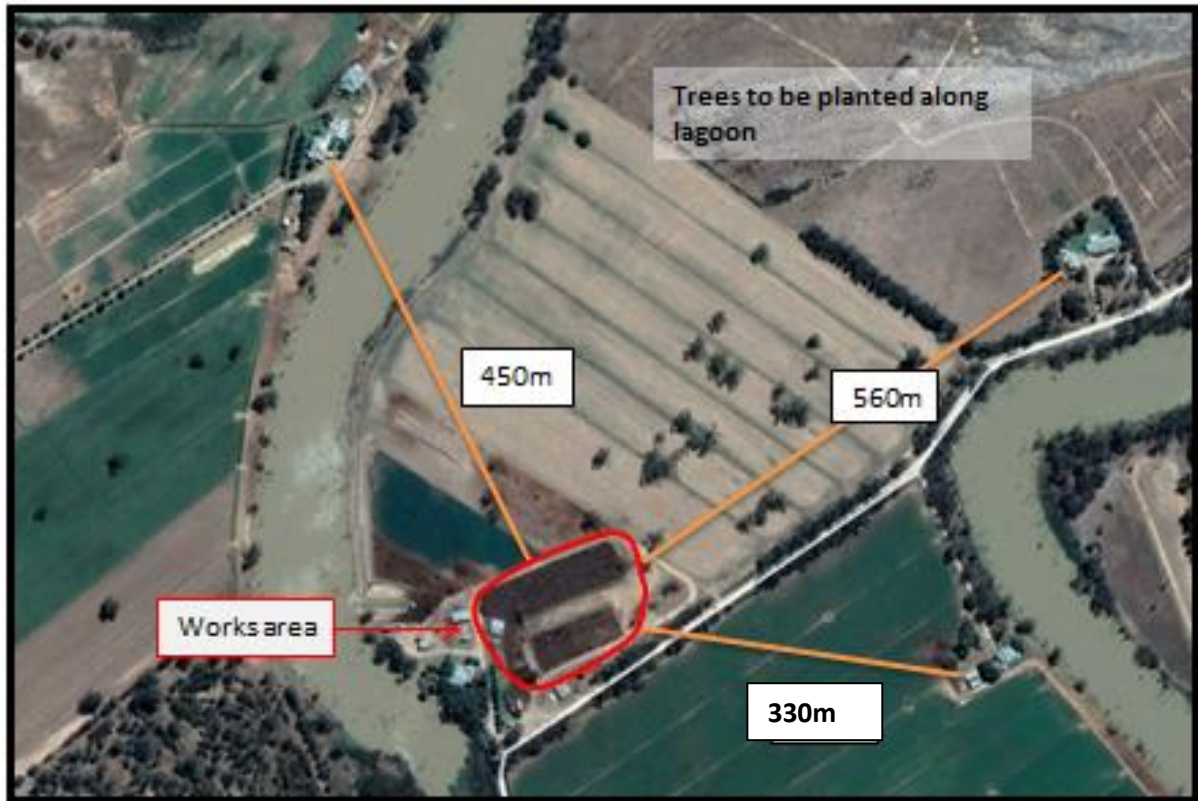
Figure 13: Existing Setback Distances at 57 Gibbon Road from feedlot works area to dwellings.

Receptor type	Direction	Separation Distance	Topography	Vegetation
18 Lavender Road	NW	450m	Flat	Scattered trees and lagoon. Grass
106 Gibbon Road	SE	330m	Flat	Remnant roadside vegetation, road
133 Gibbon Road	E	560m	Flat	Scattered paddock trees, grass
Property Boundary (road)	S	30m	Flat	Remnant roadside vegetation
Water course	W	124m	Flat	Grassed
Public Road	S	30m	Flat	Remnant roadside vegetation
Gunbower	NW	3200m	Flat	Treed, grass

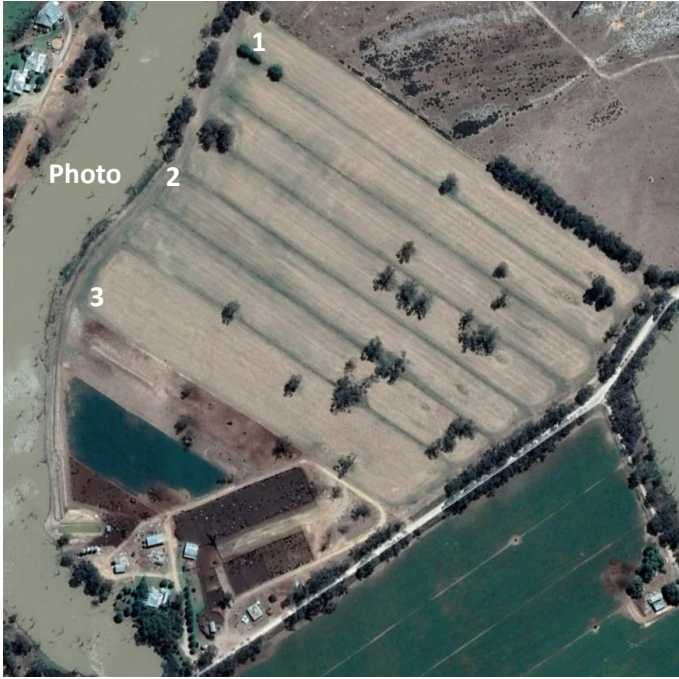
<p>1.</p>	<p>Looking north along Lagoon bank Presence of bank to prevent runoff from farm and restrict flood water entry</p>

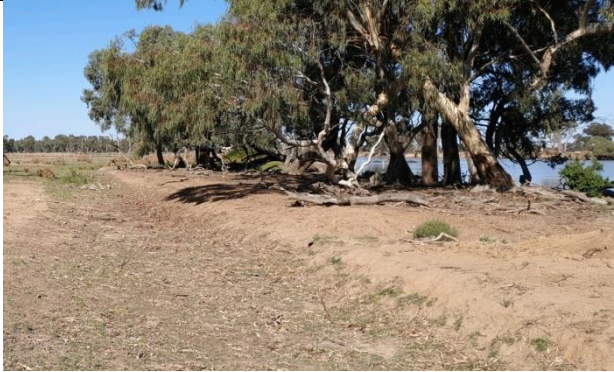
<p>2.</p>	<p>Looking South</p>

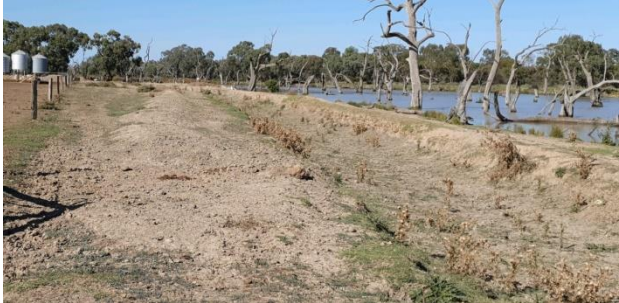
<p>3.</p>	<p>Looking south</p>

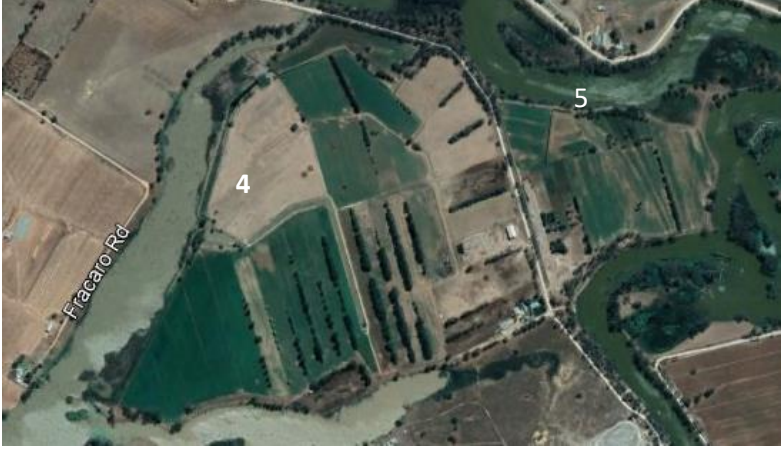
<p>4.</p>	<p>Bank along alignment of lagoon. Looking South</p>

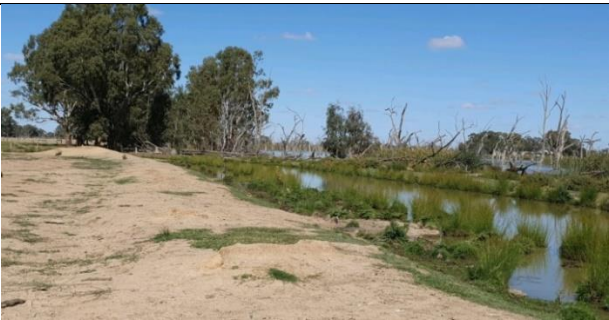
<p>5.</p>	<p>Shows pipeline under track with backflow prevention. Into internal channel. Looking South</p>

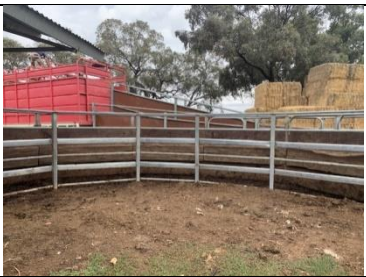
<b>Pen Floor Preparation</b>	Surface compacted and raised to provide drainage	
<b>External Surface Runoff</b>	No run off can enter nearby creeks or lagoons	All runoff graded and diverted towards central effluent pond
<b>Laneways</b>	All weather surface maintained	
<b>Cattle Handling Yards</b>	Safe, solid, steel construction on all forcing yards, crushes, races and Feedlot pens

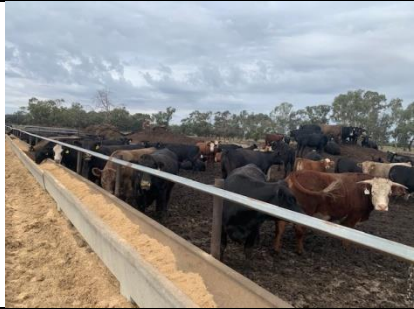
<b>Water Supply</b>	Gunbower creek irrigation supply	
<b>Internal Pen Drainage Control</b>	Pens slope back to central drain between the two rows	In event that internal catchment drain becomes full it is decanted via pump to adjoining channel to be diluted with irrigation water for application to paddocks. Historically frequency only once in ten years.

<b>Feed Troughs</b>	Concrete

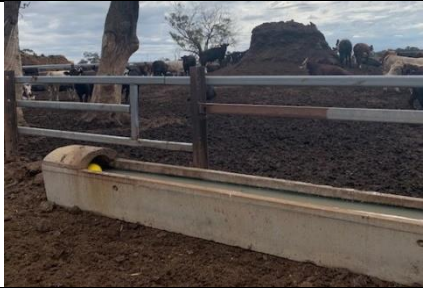
<b>Feed Trough Aprons</b>	Not installed	
<b>Water Troughs</b>	Concrete

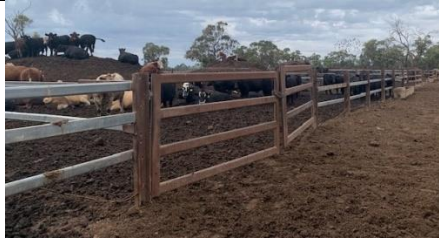
<b>Water Trough Aprons</b>	Not installed	
<b>Fencing</b>	Solid steel construction in pens Adjoining paddocks wire fencing

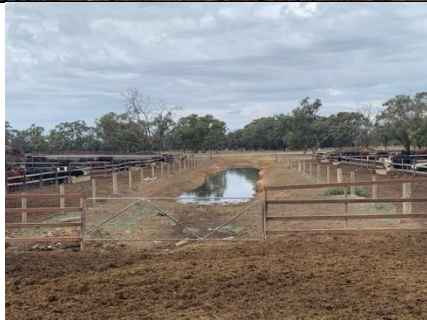
<b>Drains</b>	Central to feedlot pens. Decanted via pump for application to irrigation water. Soils of local area are clays and would have reduced permeability therefore infiltration of waste water into groundwater is minimal.

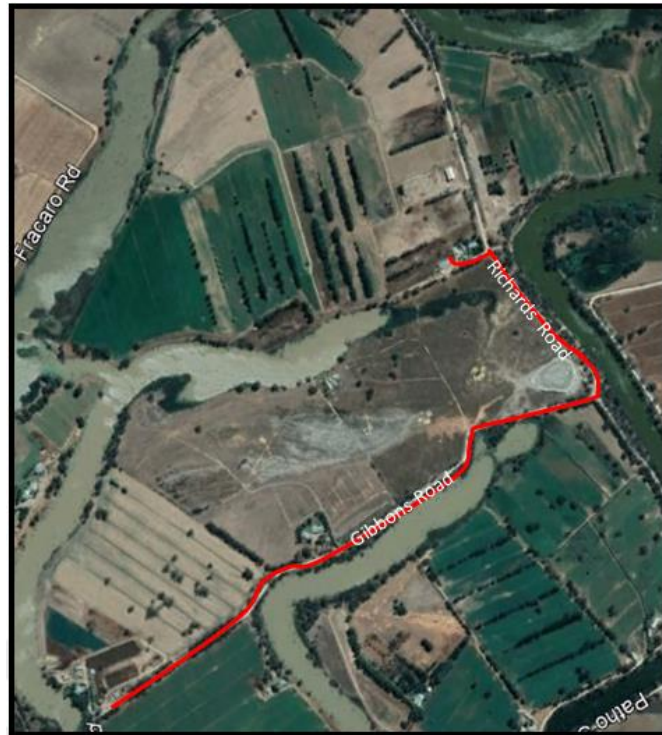
**Figure 17: Cattle Movements (2.2kms along Gibbons Road and Richards Road)**

Cattle movements between Feedlots (Site 1 & 2)	<p>Moved between the two feedlots at Site 1 and 2 are herded along the local roadways</p> <ul style="list-style-type: none"> <li>• All livestock must be effectively under control at all times when they're being moved across and along the road.</li> <li>• Cattle are moved regularly via truck</li> <li>• Signs which meet to VicRoads' guidelines must be in place while livestock are being moved and removed immediately after.</li> <li>• All private farm gates can be closed as cattle walk along the road</li> <li>• The construction of a new laneway along the Gibbons Road boundary prevents cattle from entering the road and travelling in front of 106 Gibbon Road.</li> <li>• You can only move livestock across or along a public road during daylight.</li> <li>• Any livestock deposits on any road or pavement which could cause a hazard to other road users must be removed as soon as possible.</li> <li>• Grazing of Livestock and Driving of Livestock permits are available for 6-12 months from the Campaspe Shire Council at no charge. Conditions apply.</li> </ul>
